FLOOD PLAIN INFORMATION

EAST BRANCH PERKIOMEN CREEK

BUCKS COUNTY PENNSYLVANIA

PREPARED FOR
BUCKS COUNTY PLANNING COMMISSION
AND
PENNSYLVANIA DEPARTMENT OF FORESTS AND WATERS
BY
CORPS OF ENGINEERS, U. S. ARMY
PHILADELPHIA DISTRICT
JANUARY 1971

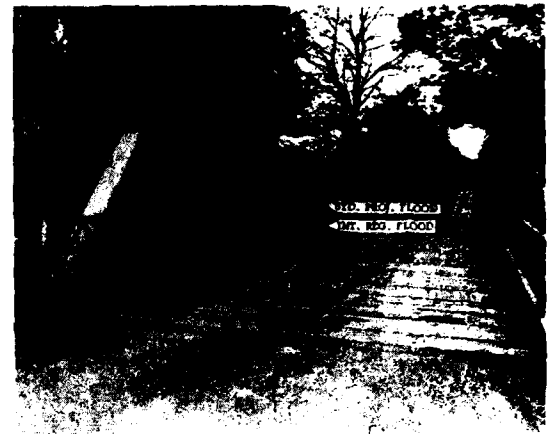
Photograph shows possible future flood heights at Bucks Road bridge.

The photograph shows the Intermediate Regional Flood and the Standard Project Flood heights in the vicinity of the Bucks Road bridge.

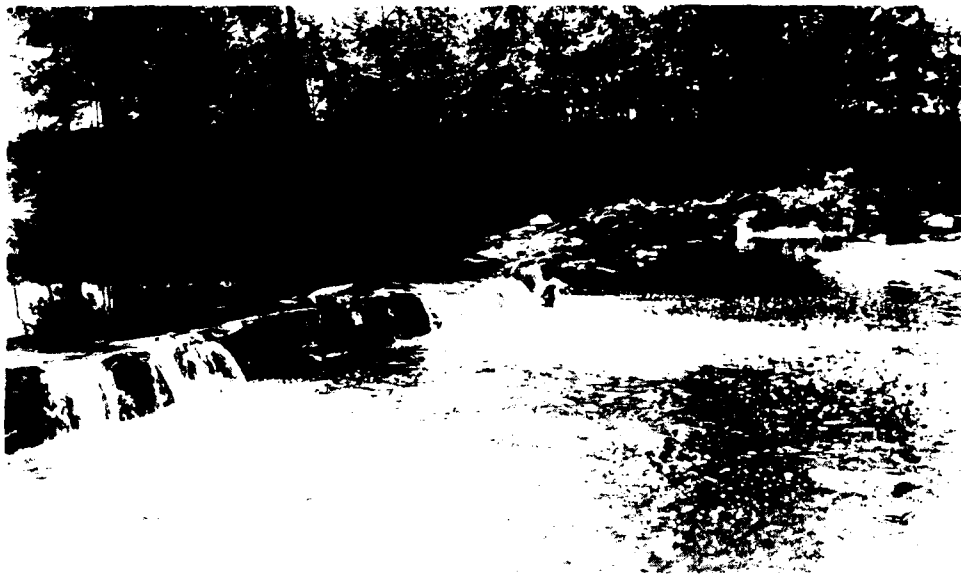
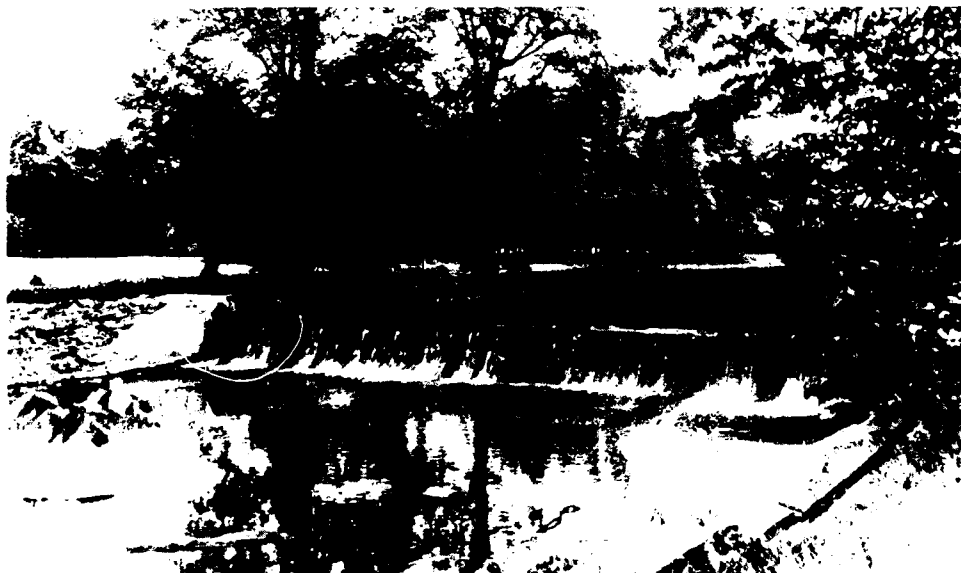
Figure 1. --DAMS ACROSS EAST BRANCH PERKIOMEN CREEK

Top view is Dam No. 2 located below the Montgomery - Bucks County Line. Bottom view is Dam No. 4 located in Lenape Park at Sellersville, Pa.

Dam No. 2 is also located in Montgomery County about 0.28 mile above Dam No. 1 and 0.46 mile below the Montgomery - Bucks County Line. It is also an old dam of rock construction with some concrete mortar and is in poor condition. The dam has a width of about 200 feet and varies from 3.5 to 4 feet in height. A shallow ponded area extends about 500 feet above the dam and has an average width of about 100 feet. The center and left bank sections of the dam have been ruptured to a considerable extent. The dam was built in the late 1920's to serve a YMCA summer camp for recreational purposes. It is now privately owned.

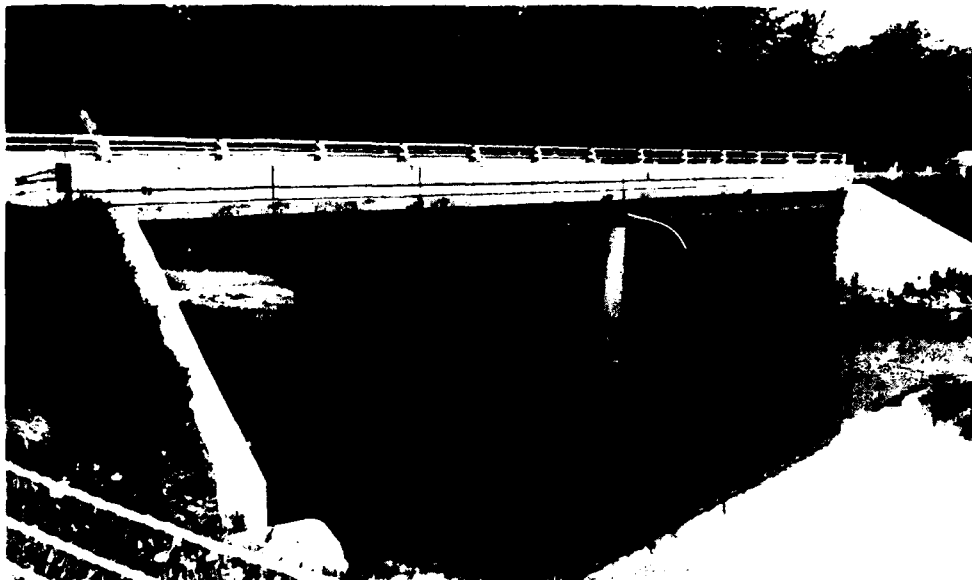
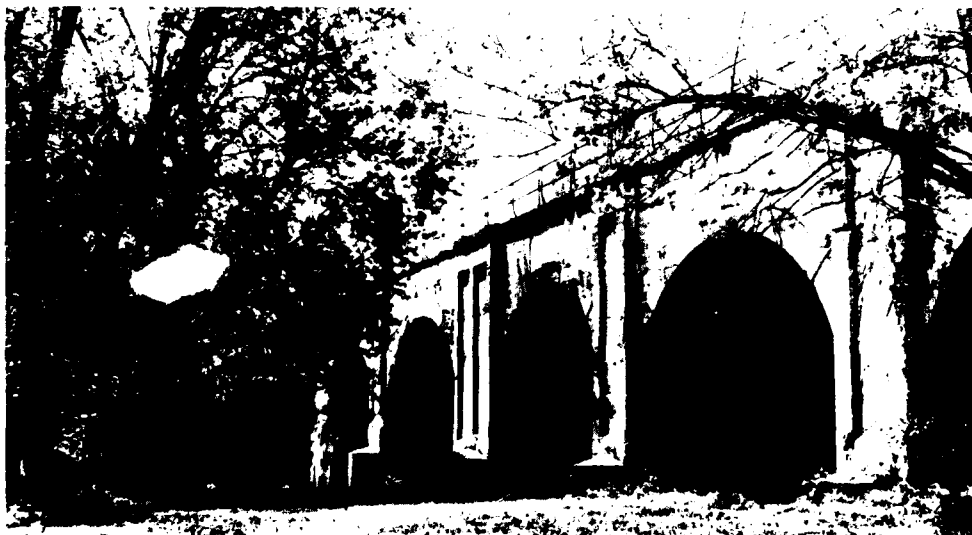
Figure 2.--BRIDGES ACROSS EAST BRANCH PERKIOMEN CREEK

Top view is the downstream side of Cowpath Road bridge at Mile 0.47. Bottom view is the downstream side of the multi-arch Reading Railroad bridge at Mile 3.83.

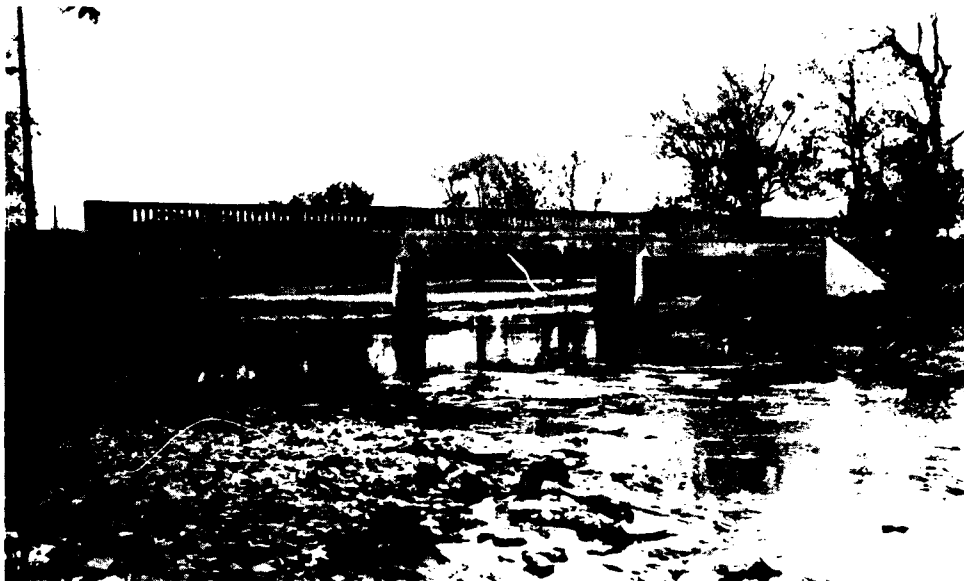
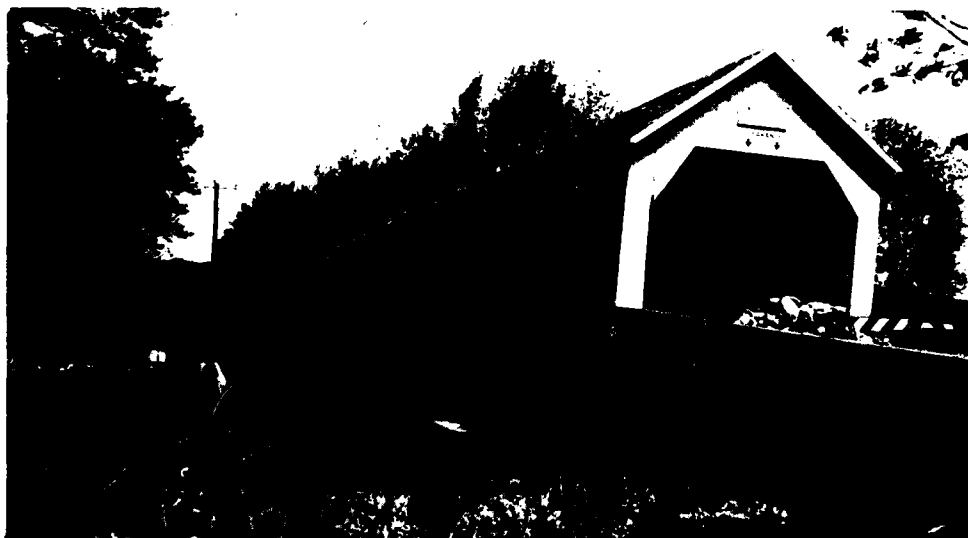
Figure 3.--BRIDGES ACROSS EAST BRANCH PERKIOMEN CREEK
Top view is the upstream side of Main Street bridge in Sellersville.
Bottom view is Moods covered bridge at Mile 6.89.

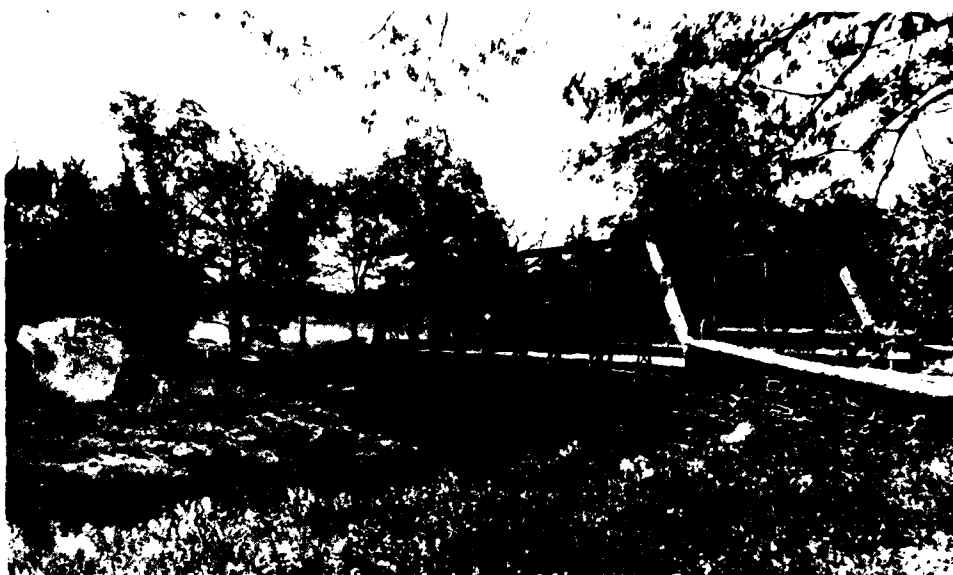
Figure 4.--BRIDGES ACROSS EAST BRANCH PERKIOMEN CREEK

Top view is the downstream side of the Schwenk Mill Road bridge at Mile 7.94. Bottom view is the upstream side of Doylestown Road (Pa. Rt. 313) bridge at Mile 8.94.

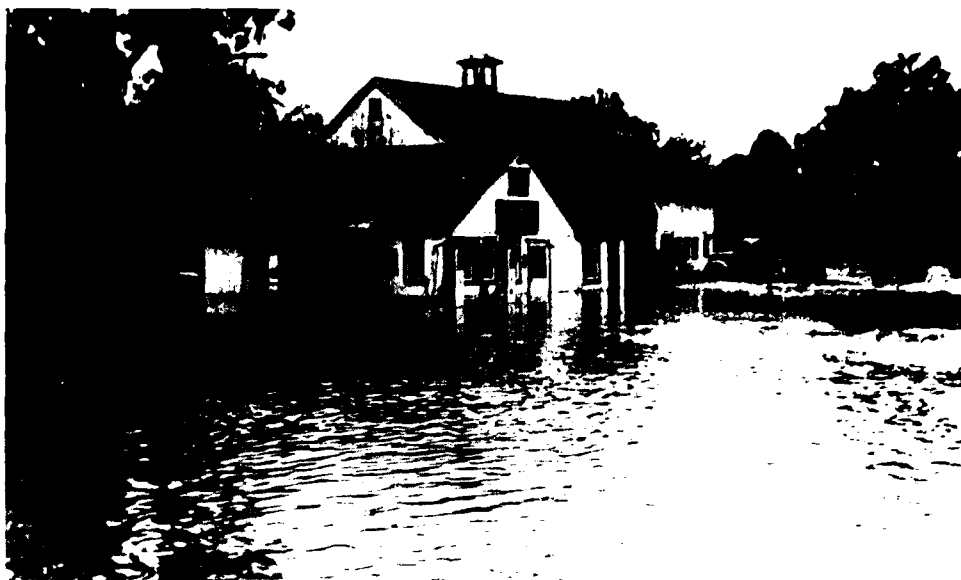
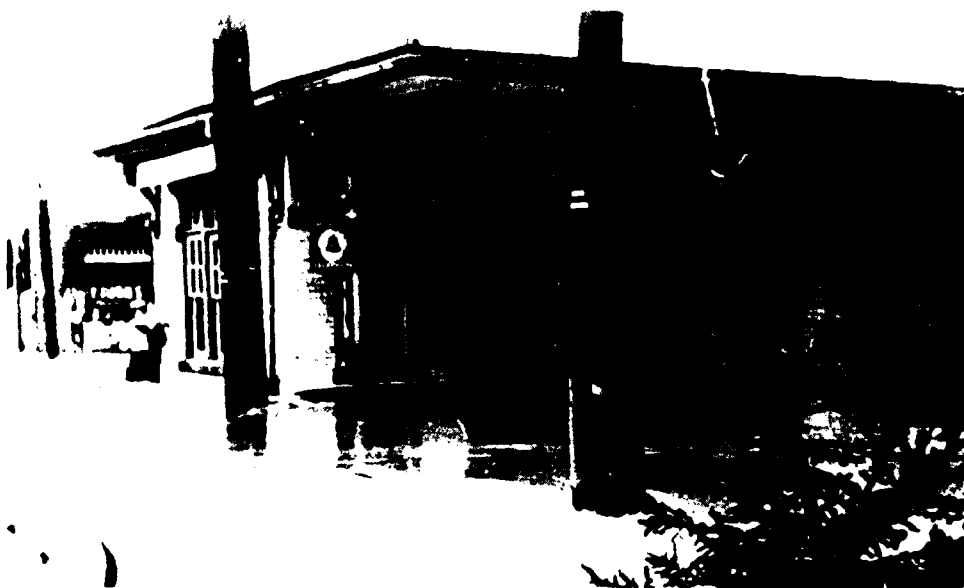
Figure 5.--FLOOD PHOTOGRAPHS IN SELLERSVILLE, PENNSYLVANIA
Photographs show the August 9, 1942 flood in the Sellersville area.

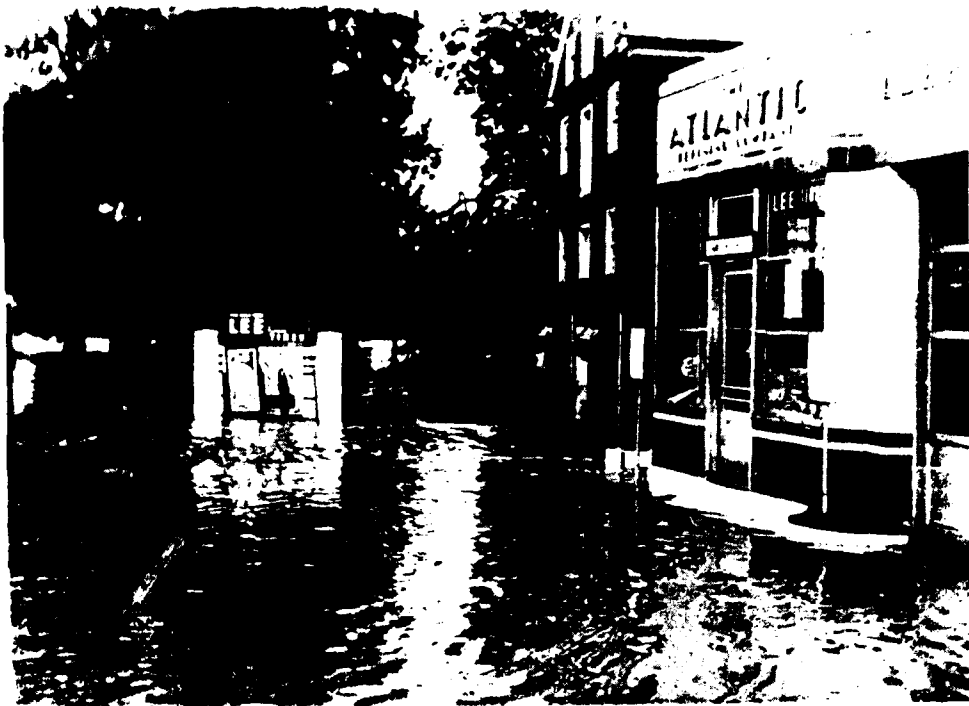
Figure 6.--FLOOD PHOTOGRAPH IN SELLERSVILLE, PENNSYLVANIA
Photograph shows the August 9, 1942 flood in the Sellersville area.

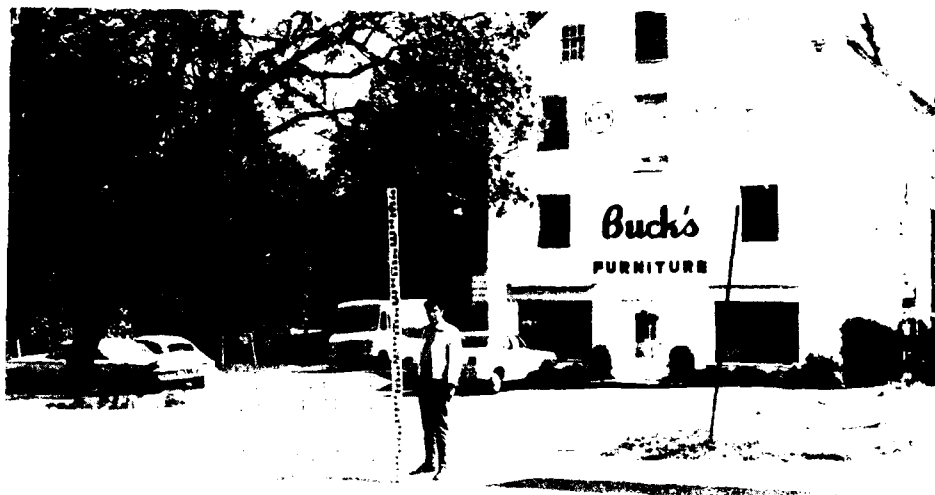
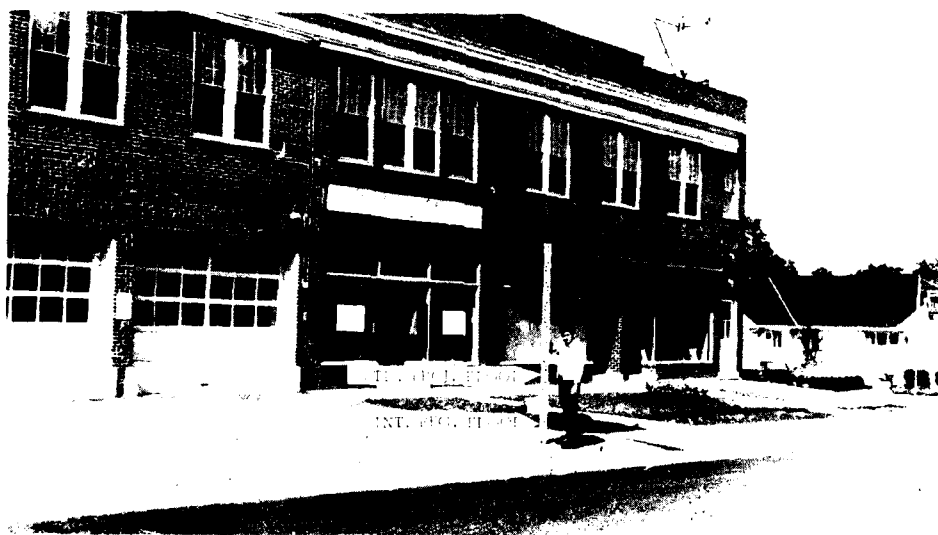
Figure 7.--FLOOD HEIGHTS ALONG EAST BRANCH PERKIOMEN CREEK

Top view is in front of Bucks Furniture Store; the arrows indicate the heights the Standard Project and the Intermediate Regional Floods could reach and the height of the 1942 flood. Bottom view was taken at the Sellersville Fire Co.; the arrows indicate the heights the Standard Project and Intermediate Regional Floods would reach.

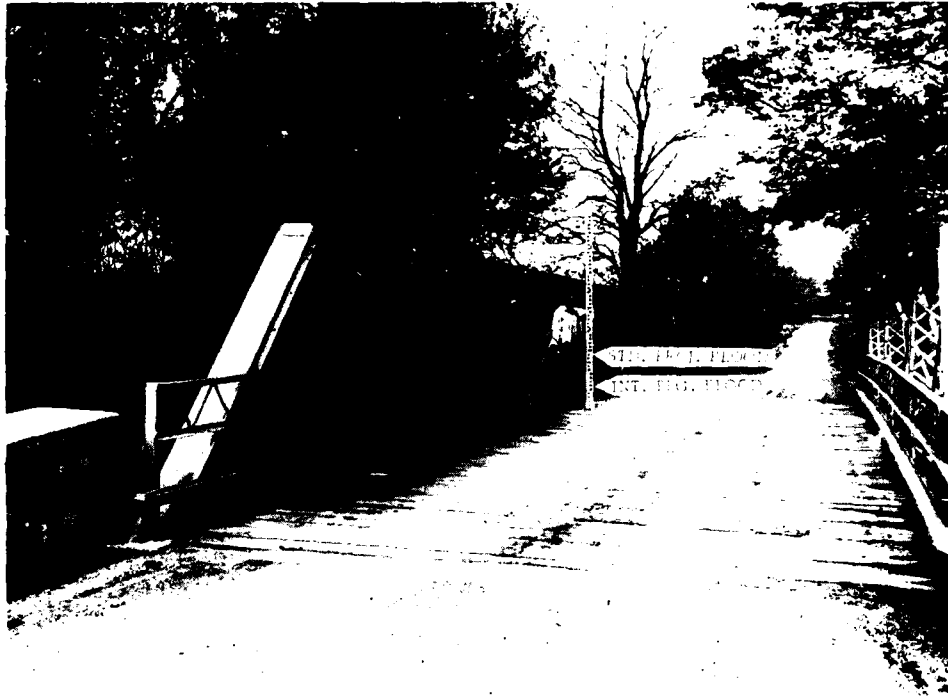
FIGURE 8.--FLOOD HEIGHTS ALONG EAST BRANCH PERKIOMEN CREEK

The arrows indicate the heights that the Standard Project and Intermediate Regional Floods could reach at Bucks Road Bridge.
